CRWR Online Report 97-3

Evaluation Of The Performance Of Permanent Runoff Controls: Summary And Conclusions

November 1997

CENTER FOR RESEARCH IN WATER RESOURCES

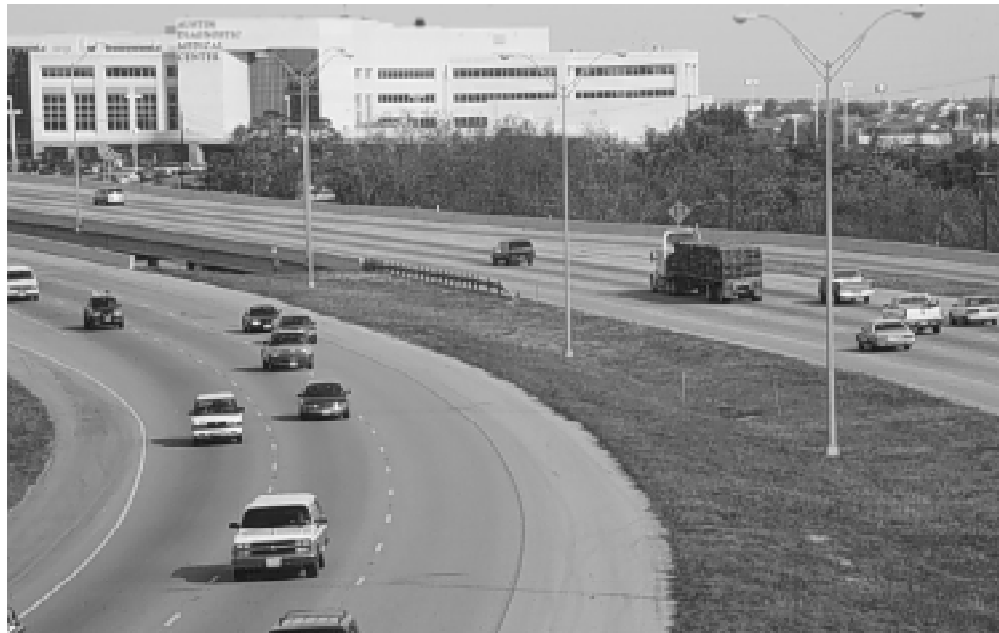
Figure 1. MoPac at Walnut Creek Filter Strip.

The vegetated buffer strip at Walnut Creek is section of highway median which collects runoff from the northbound and southbound lanes of MoPac just south of Walnut Creek in Austin, Texas (Figure 1). The median was designed originally as a hydraulic conveyance and not as a runoff treatment device. The median cross-section is V-shaped with a rounded bottom. Runoff from the highway flows as sheet flow down the sides of the grassy slope and then along the center of the median to 4 drop inlets situated along the centerline of the median. The drop inlets discharge to a storm drain that conveys the runoff to Walnut Creek. This storm drain collects runoff from the road and median, as well as from several grassy shoulder areas. Runoff directly from the highway was collected from the MoPac bridge over Walnut Creek.

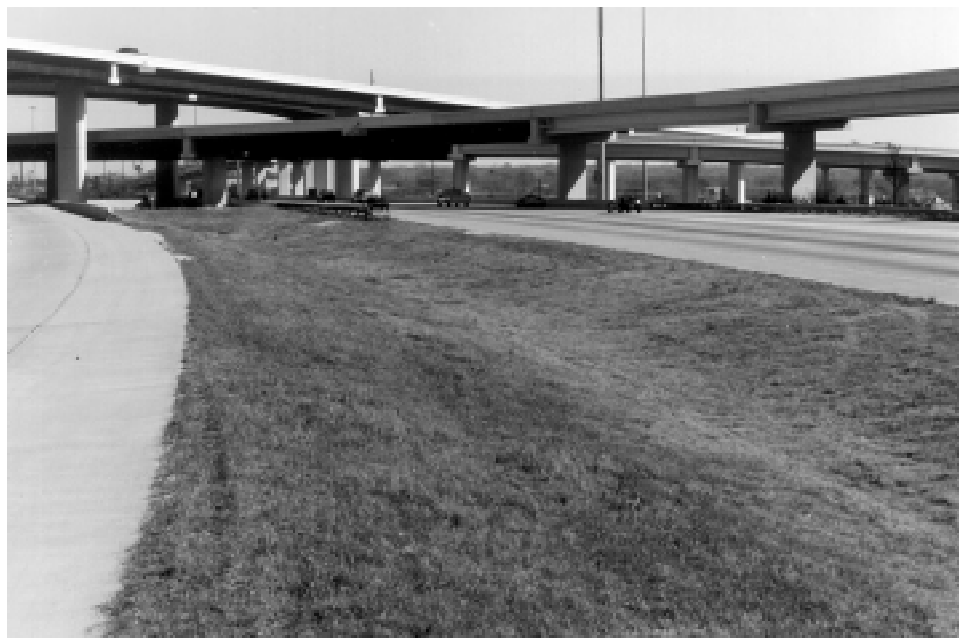
Figure 2. Vegetated Buffer Strip at U.S. 183 Site.

The vegetated buffer strip monitored at U.S. 183 at MoPac is the grassy median of U.S. 183 just north of MoPac. This median also was designed originally for hydraulic conveyance. Only the 3 southbound lanes of 183 drain into the median, which is V-shaped with a rounded bottom. The northbound lanes drain to a curb-and-gutter storm drain, providing an appropriate location for sampling road water quality at this site. This site was

monitored from March 1996 to May 1997. A summary of the characteristics of the two vegetated buffer strips is given in Table 1.

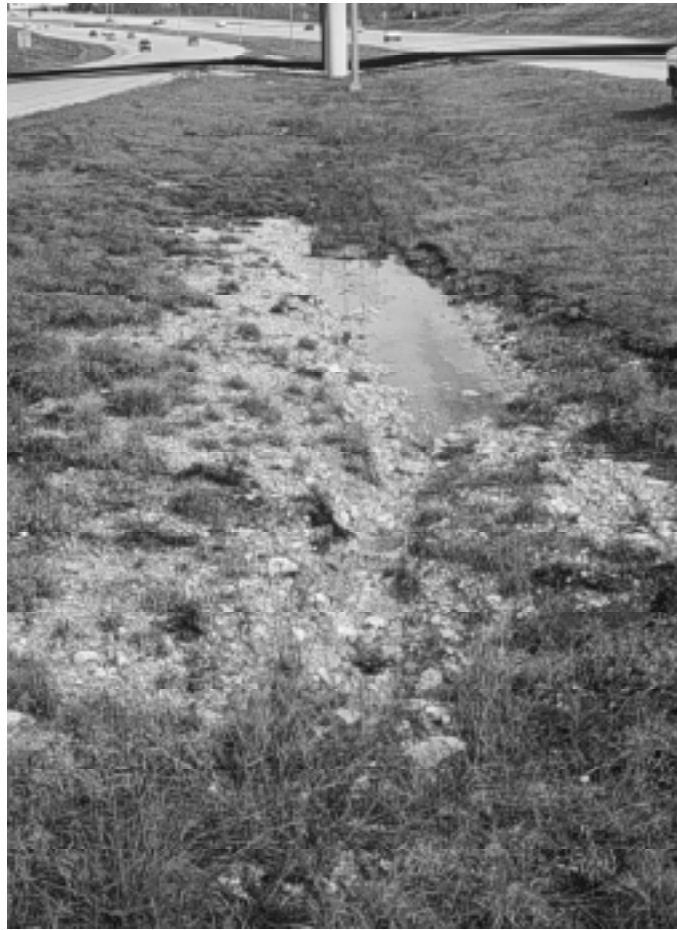
Figure 4. Erosion at the Walnut Creek Vegetated Buffer Strip.

During the monitoring phase of this study, two important observations were noted regarding filter strips; both observations demonstrate the need for proper design. Significant channel erosion occurred at the bottom of the Walnut Creek median in seven locations. The erosion exposed bedrock, which was devoid of vegetation (Figure 4). These areas diminish the effectiveness of filter strips by contributing sediment to receiving waters and reducing the amount of treatment that occurs along the length of the median. In addition, erosion can result in maintenance problems, hindering routine activities such as mowing. No erosion was noted at the U.S. 183 site, which has a lower average slope than Walnut Creek. The use of additional drop inlets along the median may alleviate the erosion at the Walnut Creek site.
